5 Florida Observations

5.1 Flood Observations: Damages and Successes

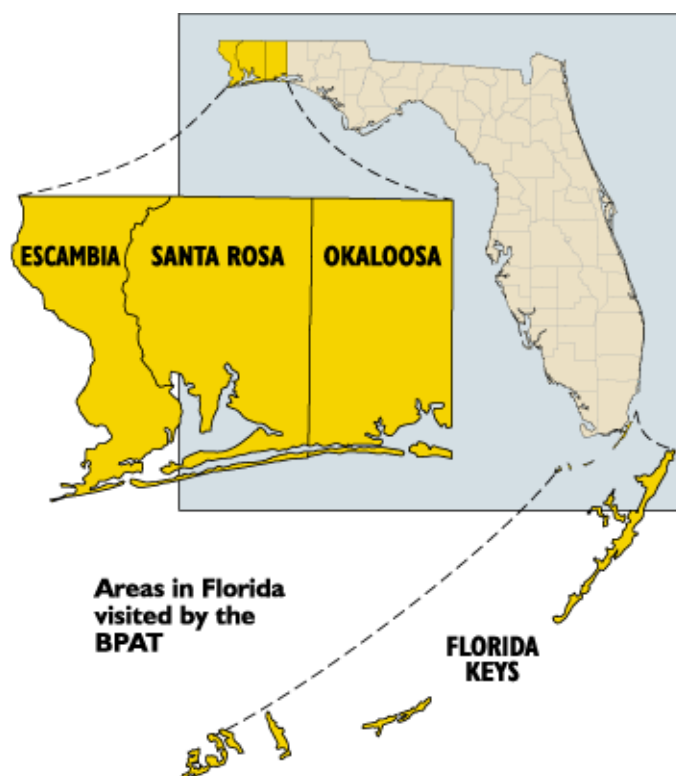
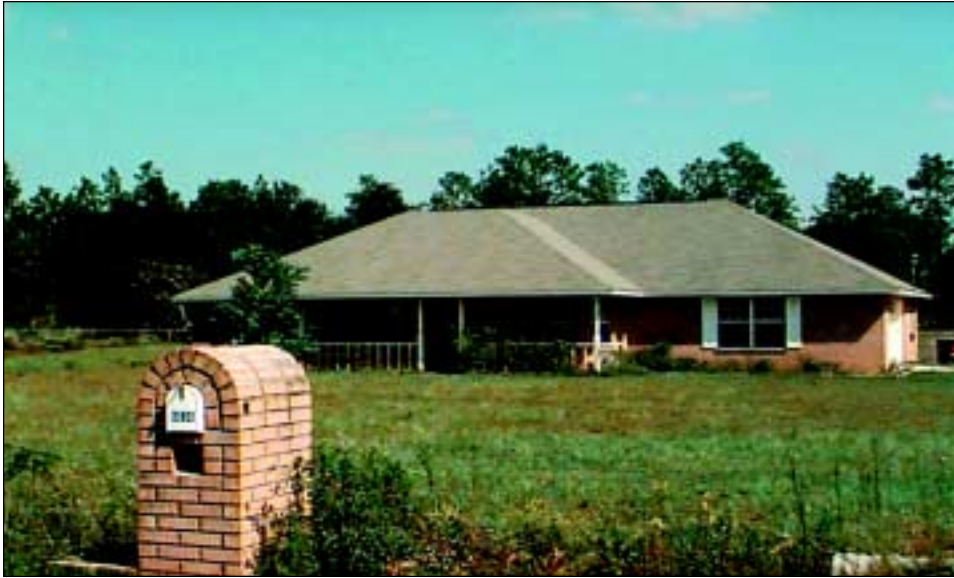
The BPAT visited sites of riverine flooding along the Yellow and Shoal Rivers in Okaloosa and Santa Rosa Counties. The home shown in Figure 5-1 was flooded by several feet of water and is typical of the pre-FIRM, at-grade houses located in these areas.

FIGURE 5-1 Repetitively flooded home slated for acquisition under FEMA's HMGP.

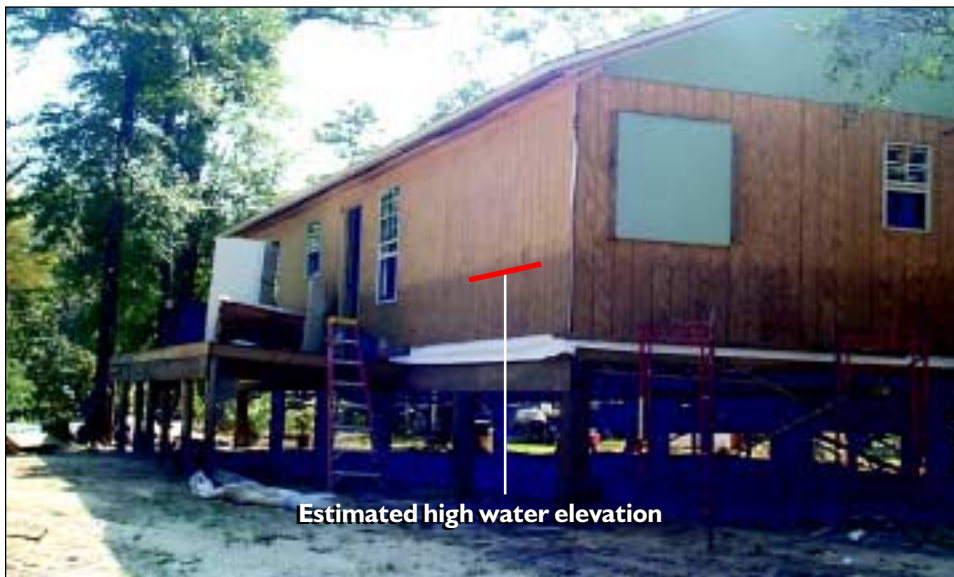
In accordance with the County's NFIP compliant floodplain management requirements, the replacement home shown in Figure 5-2 was recently built to the BFE with a Small Business Administration (SBA) disaster loan after flooding damaged it earlier this year. Floodwaters exceeded the BFE, reaching approximately 3 feet above the first-floor elevation. While the construction of the home to the BFE reduced the damages from Hurricane Georges — and will protect against damage from less intense, future storms — a residual risk still remains from floods exceeding the BFE. A freeboard requirement would have further reduced the risk of flooding. Fortunately, a condition of the SBA loan required the property owner to maintain flood insurance coverage on the home. Proceeds from the insurance claim will help the homeowner recover from this flood.

FIGURE 5-2 A high water mark is visible approximately 3 feet above the first floor elevation. The house, located along the Shoal River in Okaloosa County, suffered little damage because insulation and wallboard had not yet been installed.

The BPAT assessed damage from riverine flooding on the Shoal River that exceeded the base flood level by several feet. Homes elevated to the BFE flooded when water levels exceeded the BFE, as was the case with the home in Figure 5-2. Homes built outside, but adjacent to, the SFHA were flooded when water levels exceeded the limits of the SFHA. Homes in Figure 5-3 were built in the last five to seven years and they experienced significant flooding and damage when water levels exceeded the BFE and the limits of the SFHA.

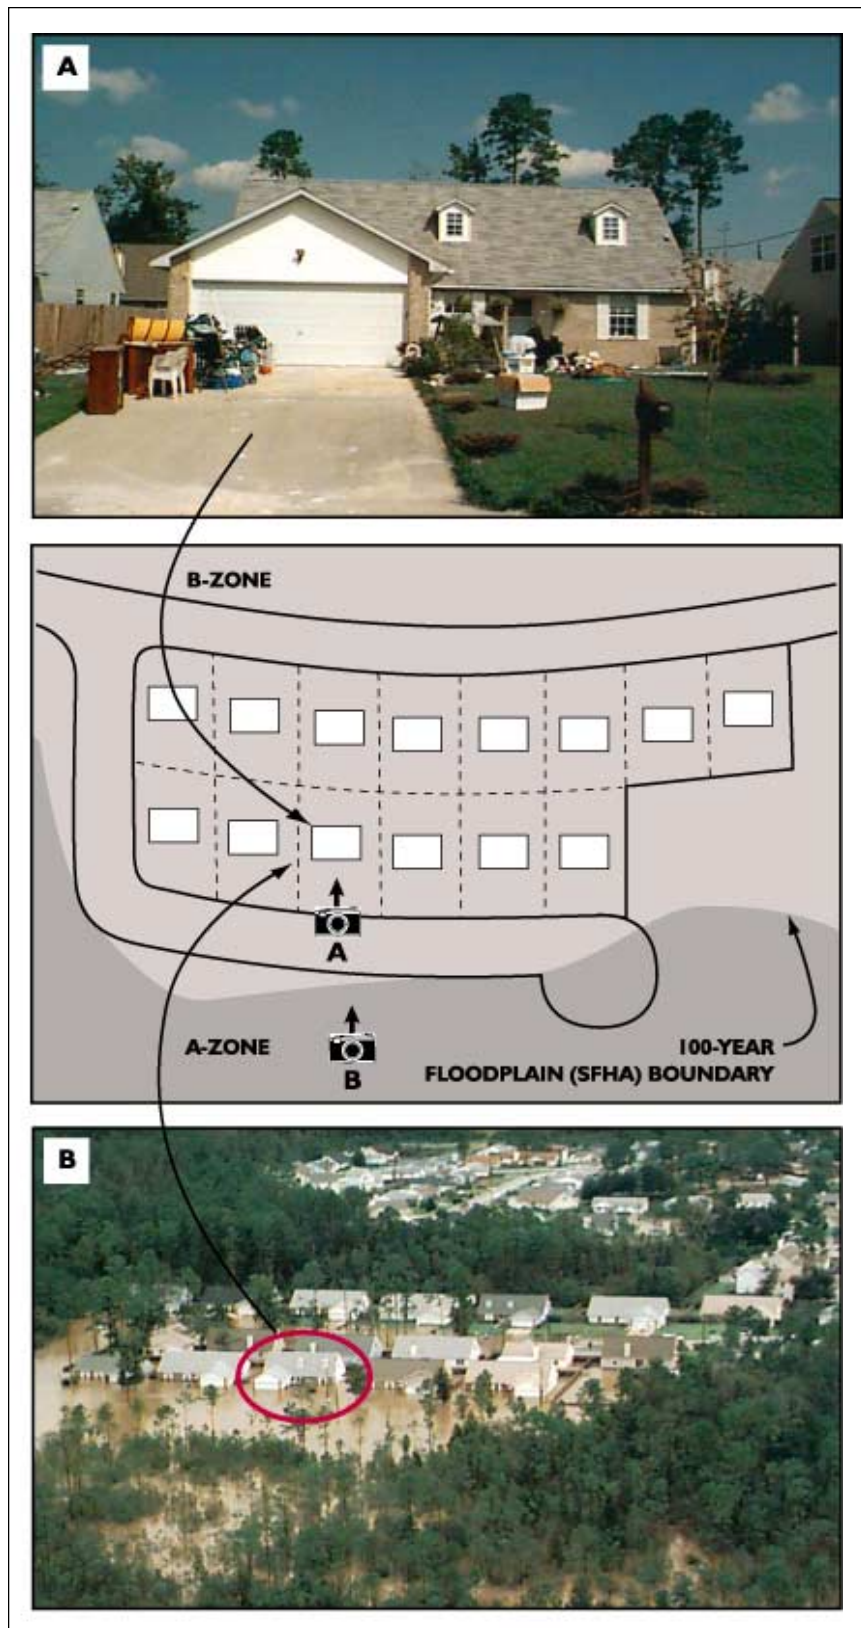
While locating homes directly adjacent to but outside the SFHA may eliminate both the mandatory flood insurance purchase requirement and floodplain management construction requirements, the risk of flooding is not completely eliminated. This residual risk, without the financial protection of flood insurance coverage, left many homeowners whose flooded homes were located outside the SFHA, ill-prepared to recover from flood damage caused by Hurricane Georges.

FIGURE 5-3 The home pictured above is one of approximately 10 homes in this subdivision which experienced flood depths of 2 to 3 feet when the water levels exceeded the BFE and extended beyond the limits of the SFHA.

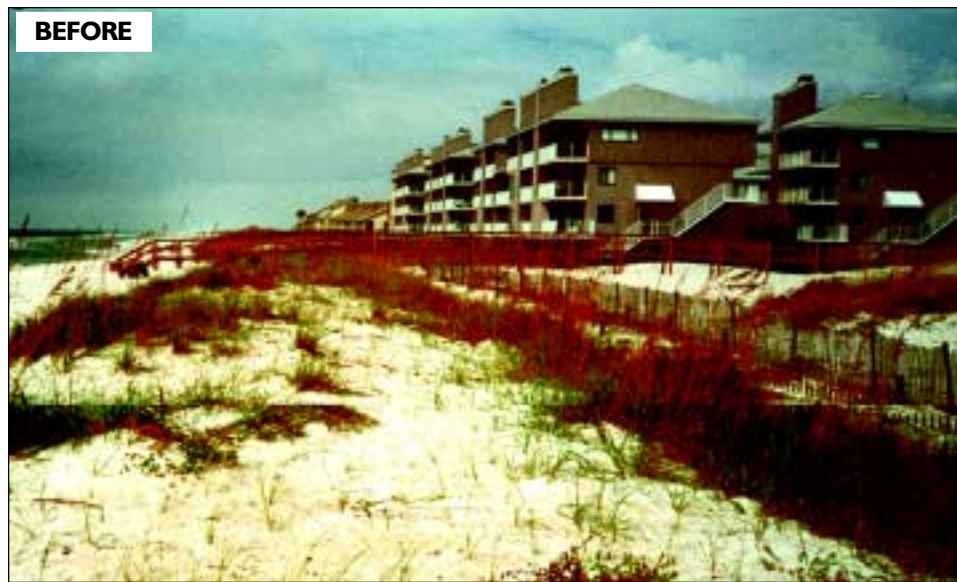
FIGURE 5-4 Pensacola Beach before Hurricane Georges.

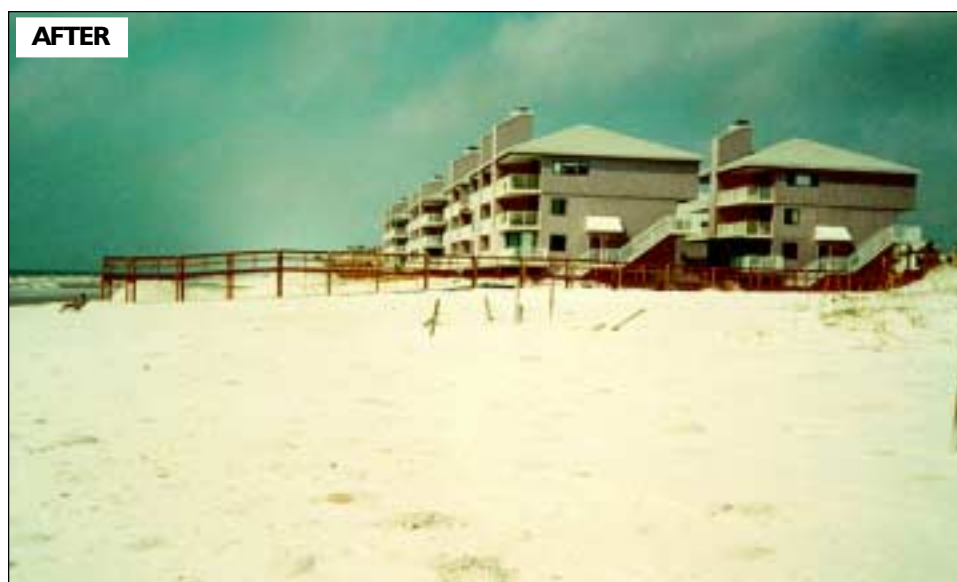
In Pensacola Beach, prolonged wave attack and storm-surge flooding associated with the hurricane eroded most of the primary dune system and narrowed the beach (Figures 5-4 and 5-5). Overwash was significant, but not as severe as experienced during Hurricane Opal. Vertical sand accretion beneath some structures was 3 to 5 feet. Even after Hurricane Georges, Pensacola Beach remains relatively wide with scattered residual dunes. Offshore sandbars were observed migrating back onto the beach in some locations.

FIGURE 5-5 Pensacola Beach after Hurricane Georges. Note the loss of dune and vegetation in the foreground of the photo.

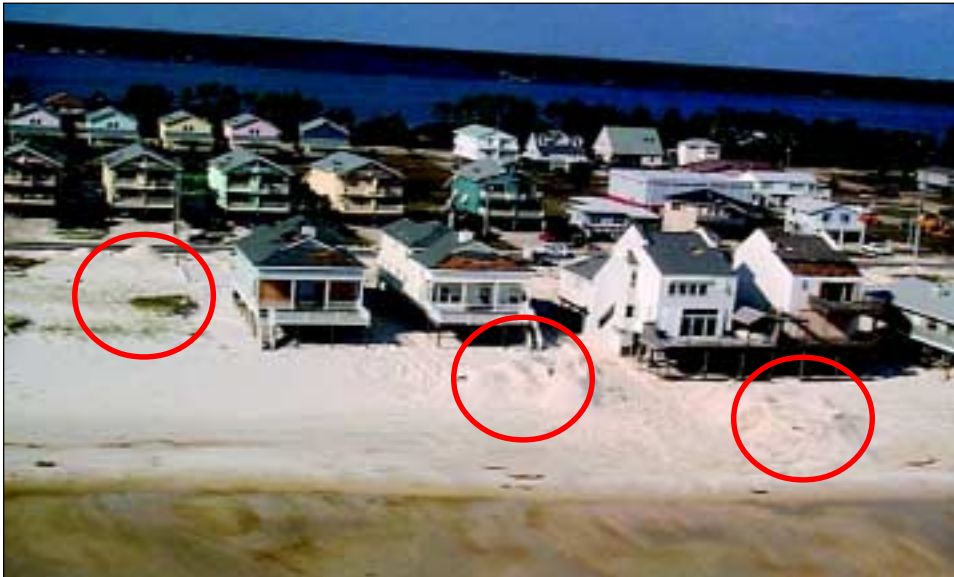
Much of the sand that was washed inland buried roads, utilities and lower areas of buildings. As shown in Figure 5-6, homeowners removed excess sand.

FIGURE 5-6 Excess sand (circled) from beneath houses and on roadways that was returned to the beach.

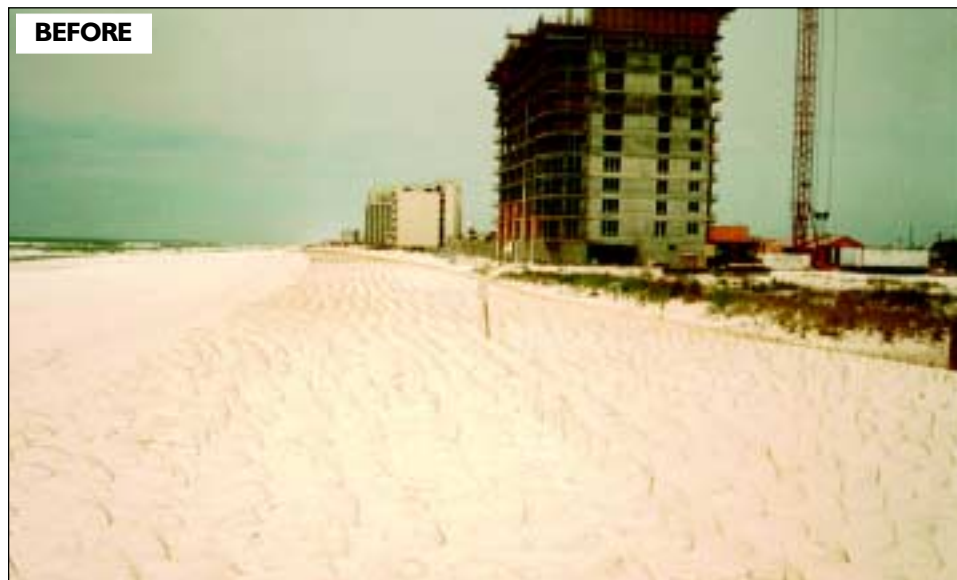
FIGURE 5-7 Navarre Beach before Hurricane Georges.

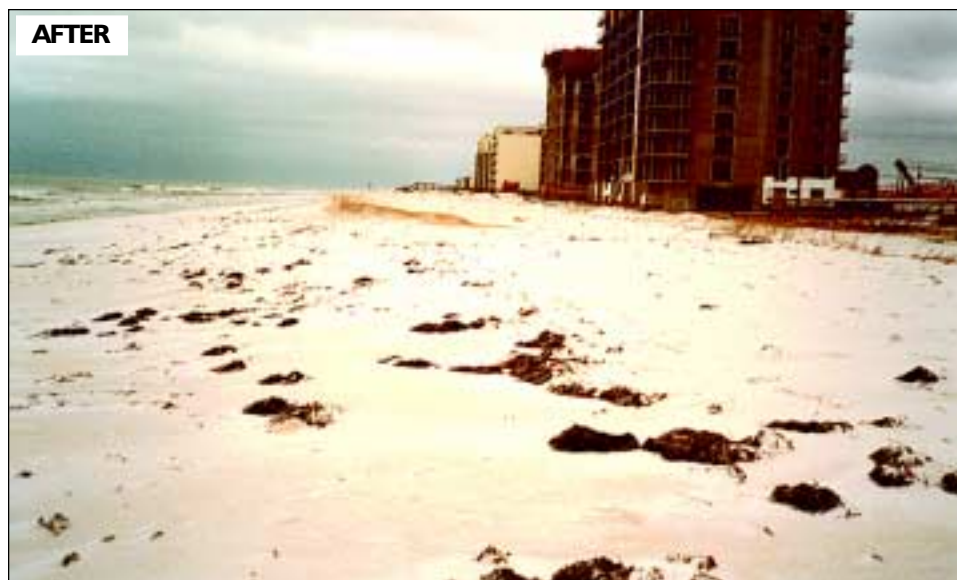
The volume of overwashed sand made the road from Pensacola Beach to Navarre Beach impassable. Reportedly, significant portions of the post-Hurricane Opal reconstructed dune in Navarre Beach were lost (Figures 5-7 and 5-8).

FIGURE 5-8 Navarre Beach after Hurricane Georges. Note the loss of revegetated dune.

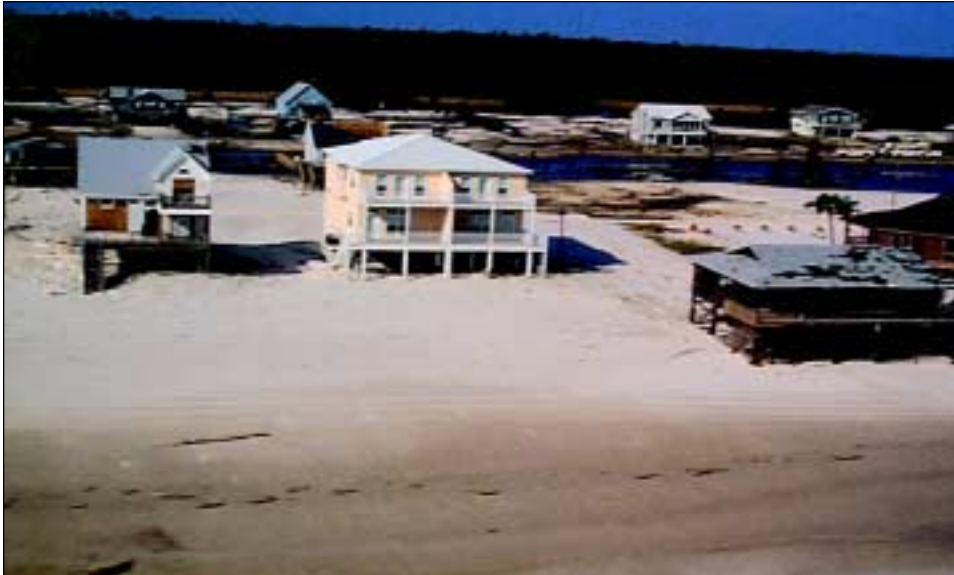
In Pensacola Beach, post-FIRM elevated structures performed well, suffering only residual damage to storage, access, and parking areas below the first floor (Figure 5-9). In V-Zone areas, the BPAT observed minimal enclosures below the first floor of elevated structures. Breakaway walls, where observed, performed as intended.

FIGURE 5-9 The structures to the left were elevated and set back and performed well.

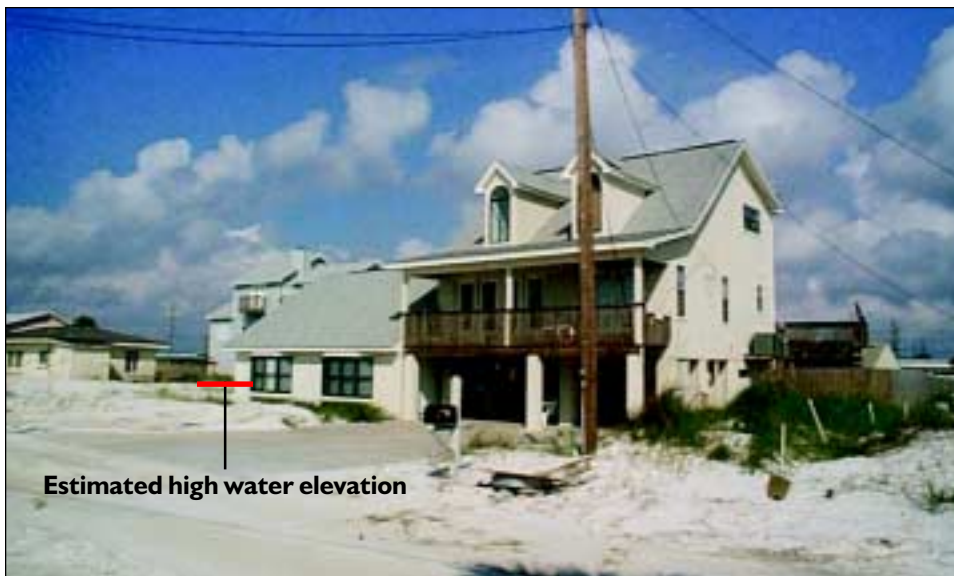
The house in Figure 5-10 clearly illustrates the reduction in flood damages that occur when homes are properly elevated. The elevated addition suffered no damage while the pre-existing, at-grade portion of the home suffered extensive flood damage from overwash.

FIGURE 5-10 An existing slab-on-grade home was expanded with a properly elevated addition.

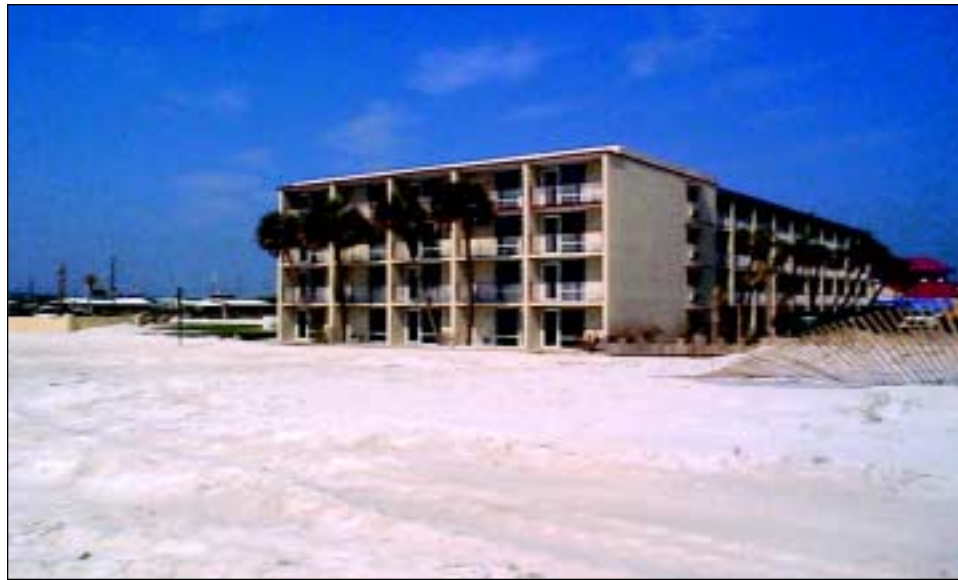
The BPAT also investigated the performance of several Pensacola Beach hotels. Older, pre-FIRM buildings, such as the hotel in Figure 5-11, suffered flood damage. Flood and rain damage forced the hotel in Figure 5-11 to close for repairs. The property management company reported that it would be closed for three to four months, forcing the layoff of approximately 50 housekeeping and support staff. In contrast, newer hotels with elevated first floors in compliance with the current floodplain management ordinance suffered minimal damage (Figure 5-12). The hotel in Figure 5-12 suffered minimal damage and was able to continue operations without disruption.

FIGURE 5-11 An older hotel that suffered significant damage to the interior due to storm surge and roof leakage.

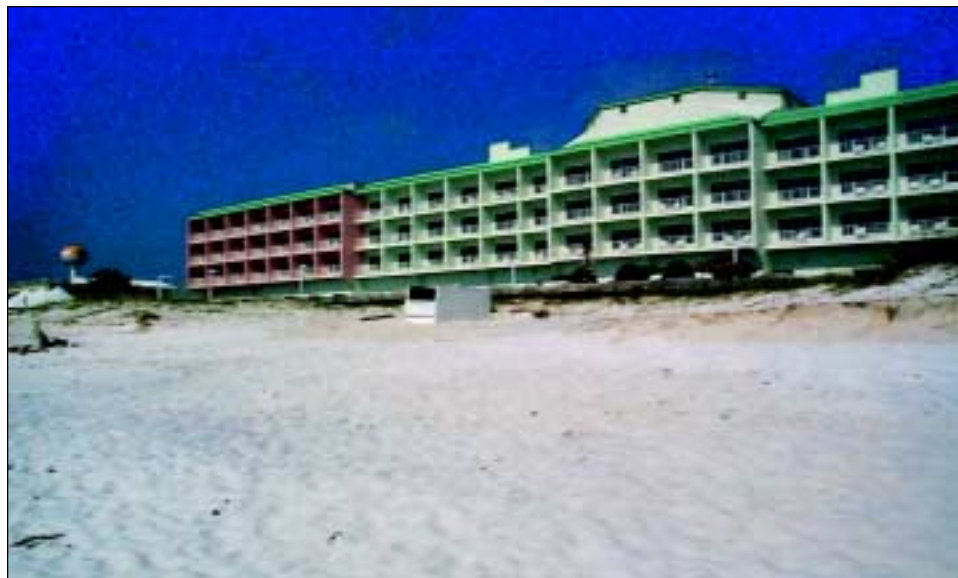
FIGURE 5-12 A newer hotel with an elevated first floor that suffered minimal damage.

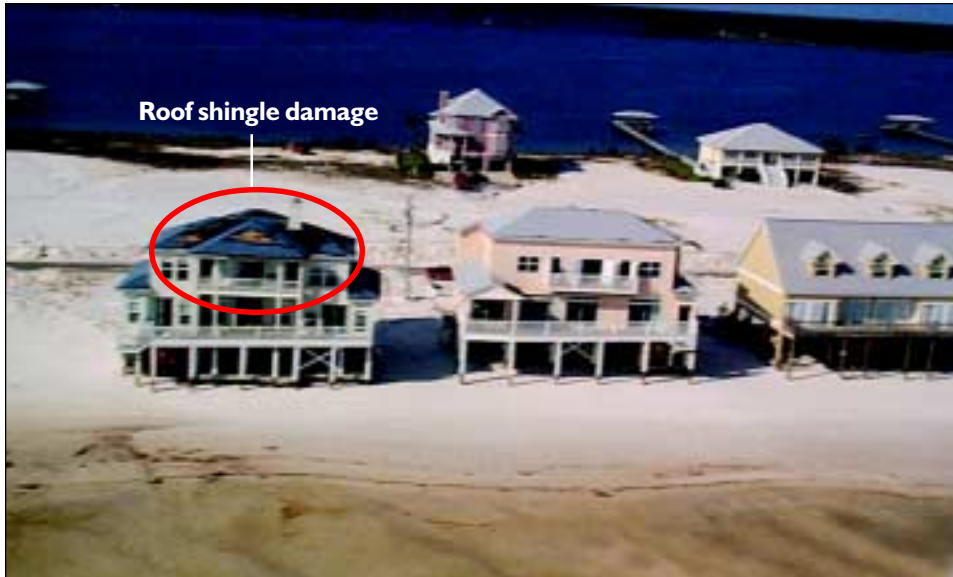
In general, Hurricane Georges caused minimal wind damage in Florida. Buildings highly exposed along the open coast suffered some wind damage, including loss of sections of composition roof shingles and small sections of siding, which allowed rain infiltration to damage building interiors and contents (Figure 5-13).

FIGURE 5-13 The house on the left suffered wind damage to roofing shingles.

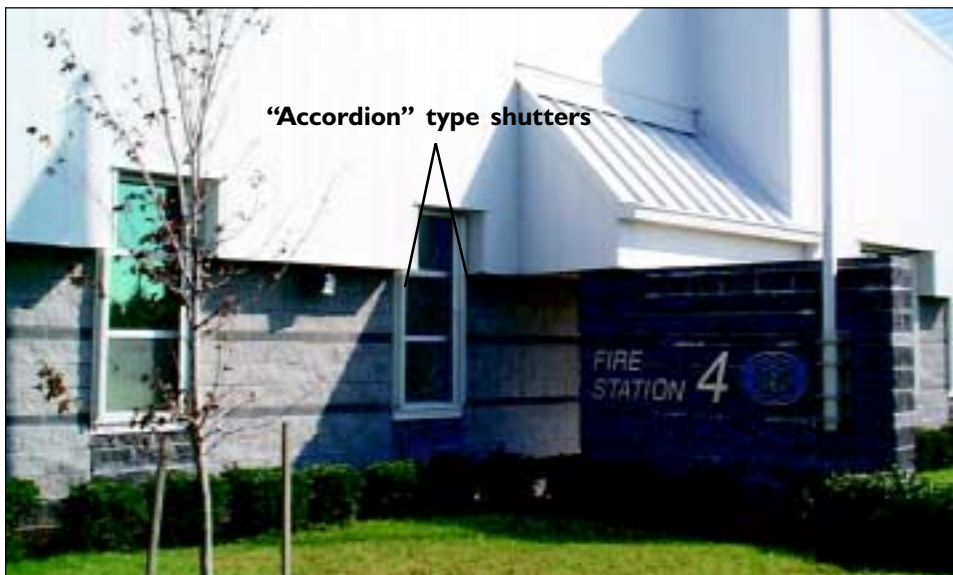
FIGURE 5-14 Window shutters on the Pensacola Fire Station No. 4.

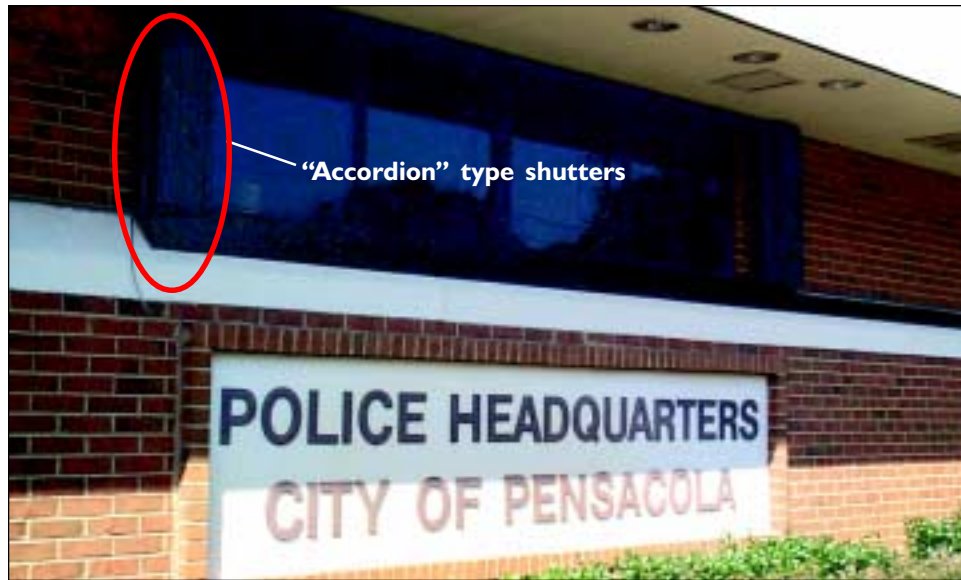
FIGURE 5-15 Window shutters on the Pensacola Police Headquarters.

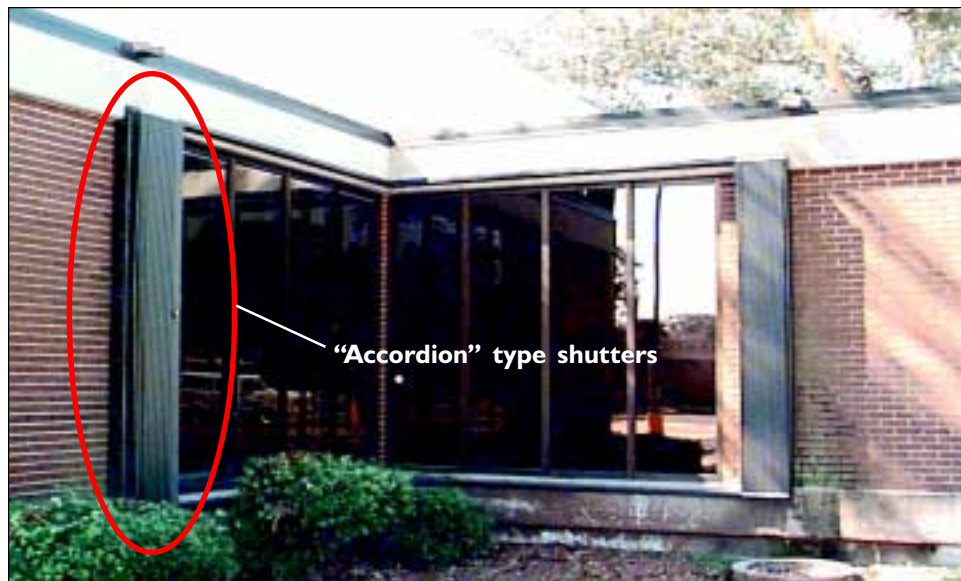
FIGURE 5-16 Window shutters on the Escambia County Administration Building.

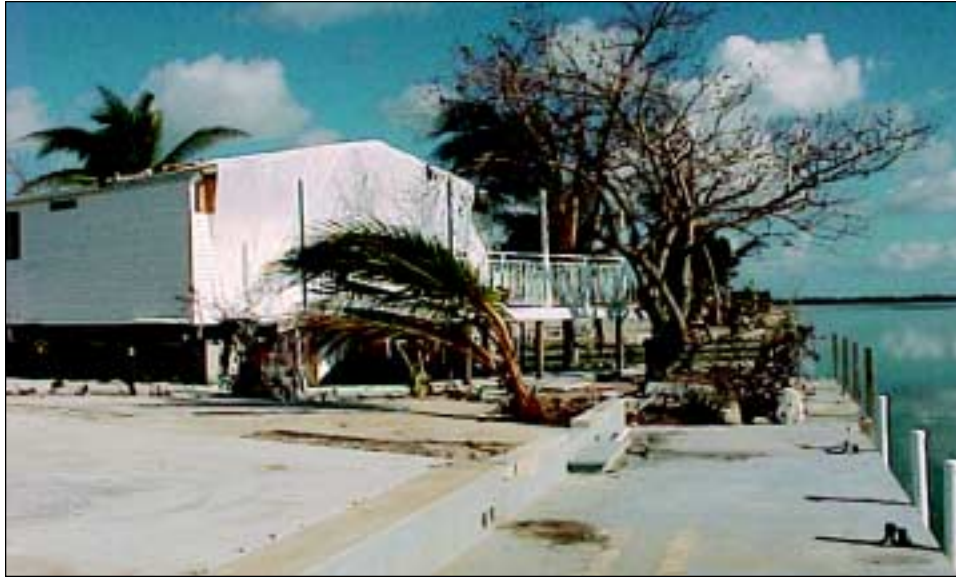
Wind and coastal storm surge damages were evaluated on Cudjoe Key. Elevated homes were exposed to only limited storm surge; most damage was attributed to wind. In general, manufactured homes built after implementation of the new HUD and state regulations (July 1994) performed much better than older (pre-1994) manufactured homes. Damage to the newer homes was superficial and often could be attributed to an attached awning or the impact of airborne debris from an adjacent structure. The manufactured home in Figure 5-17 was located directly in the path of the storm just to the east of the eye and received maximum wind exposure. The home itself sustained only ancillary damage as a result of the awning being torn away.

FIGURE 5-17 This home suffered damage when its awning blew off. The lot next door contained an older manufactured home that was completely destroyed by high winds and coastal surge.

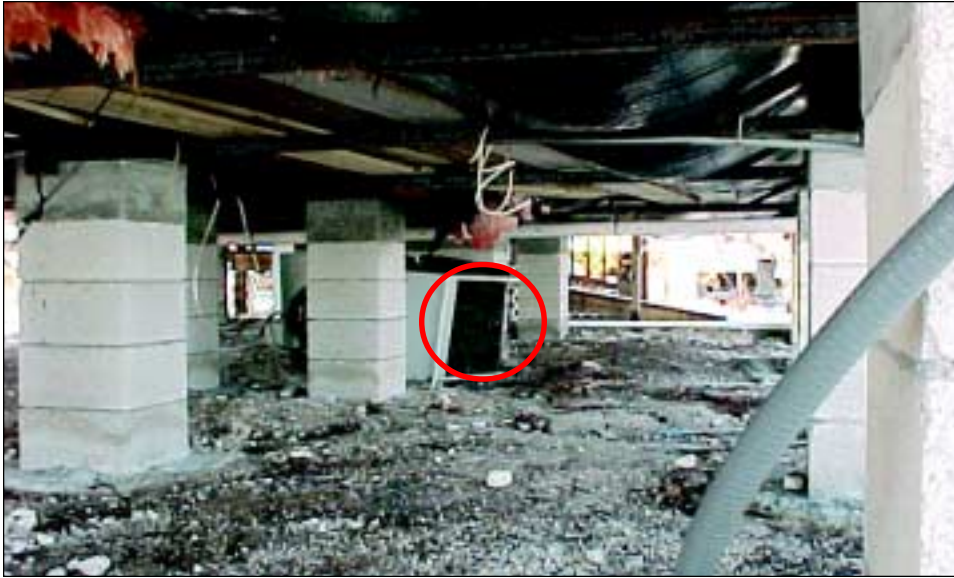
Foundation systems for the manufactured homes installed during the past four years were typically reinforced concrete or reinforced masonry piers (Figure 5-18). These homes were at or above the coastal storm surge elevation experienced during Hurricane Georges. Most of these homes experienced only non-structural damage to lower area skirting. In some cases, water damage occurred to insulation below the floor.

FIGURE 5-18 Reinforced masonry pier foundation system under a newer manufactured home that performed well. The air conditioner compressor (circled) washed under the home provides evidence of the coastal surge at this location.

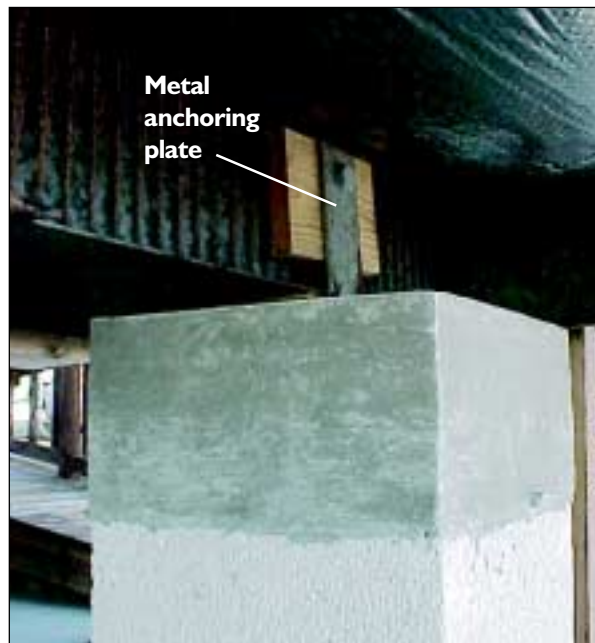
Homes generally appeared to be well anchored to the foundation piers. Many had steel plates attached to the piers and secured to the frame with large bolts (Figure 5-19). There were usually at least three connections per beam under the home. The minimum number observed was two, located at the ends of each beam.

FIGURE 5-19 Reinforced masonry pier with metal anchoring plate.

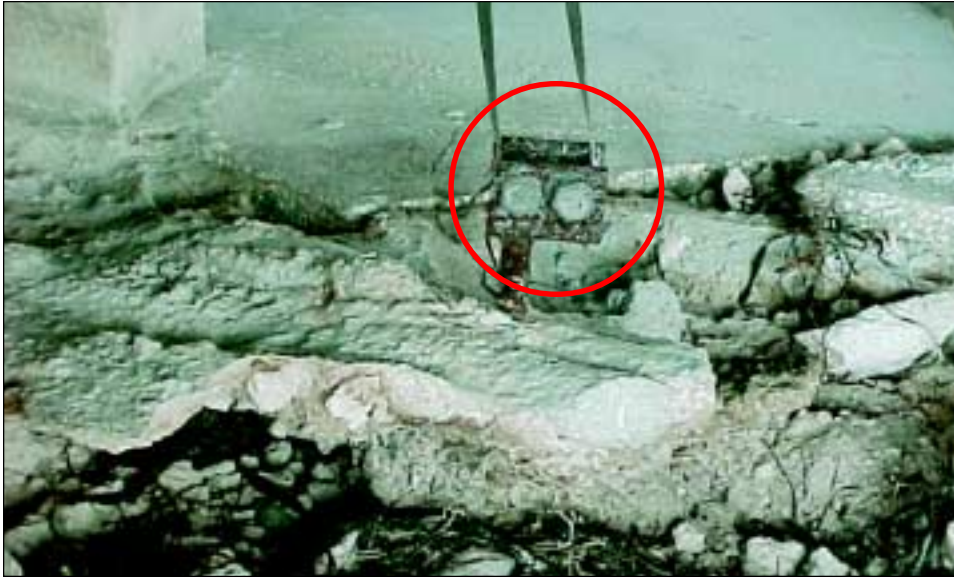
Some of the anchoring and installation problems observed on older homes included poorly attached anchors, lack of corrosion resistant materials, and homes not anchored tightly against support piers (Figures 5-21 to 5-23). Another anchoring problem observed was improperly attached tie-down straps (Figure 5-24). Figure 5-25 shows a correct strap installation that was observed.

FIGURE 5-21 This anchor is only encased on the edge of the concrete fill pad and could easily be dislodged when the home is subjected to more severe wind or flood loads.

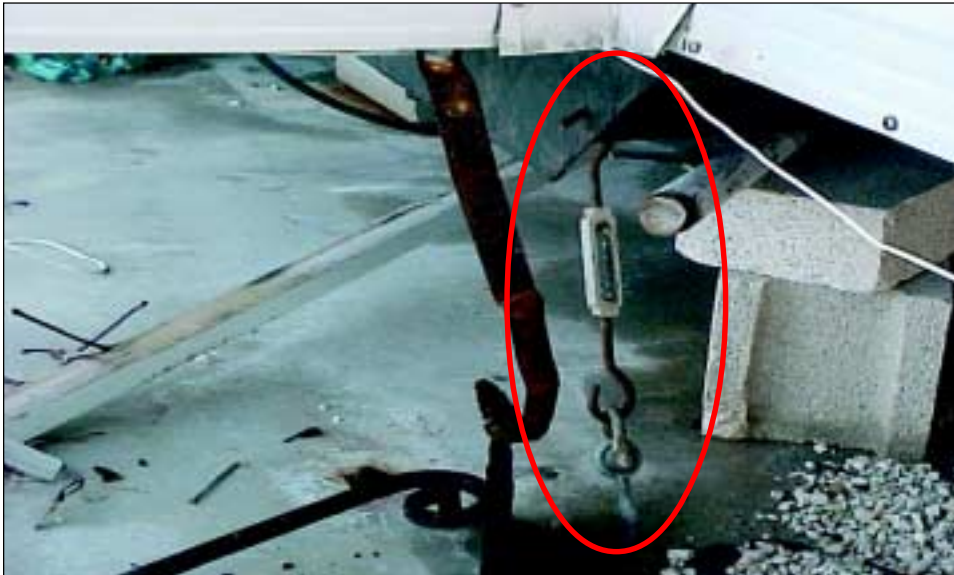
FIGURE 5-22 Inadequate turnbuckle anchor installed by homeowner on this older manufactured home. The home was severely damaged due to the lack of elevation, an unreinforced foundation system, and poor anchoring.

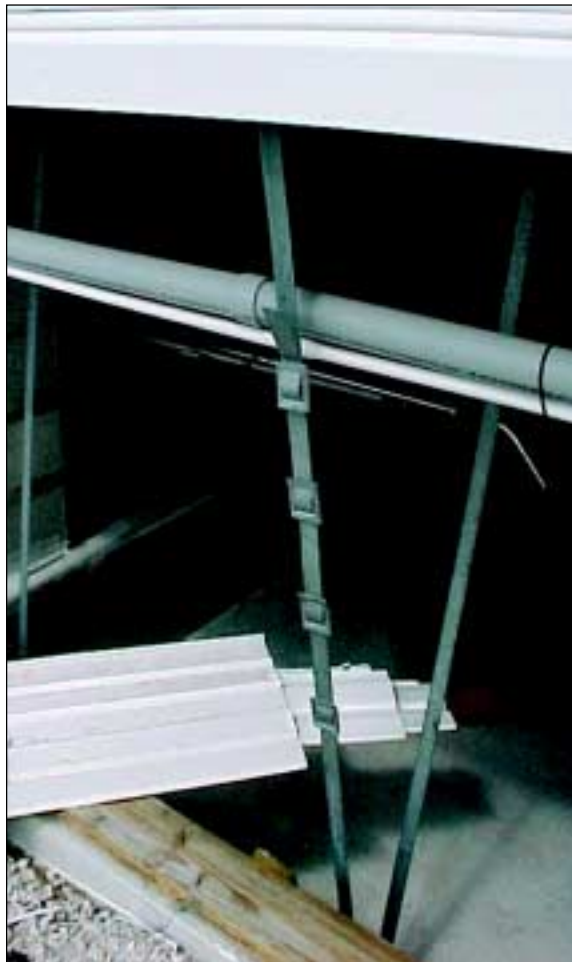
FIGURE 5-24 Improper strap installation. The buckle should be positioned where the strap wraps around the beam as shown in Figure 5-25.

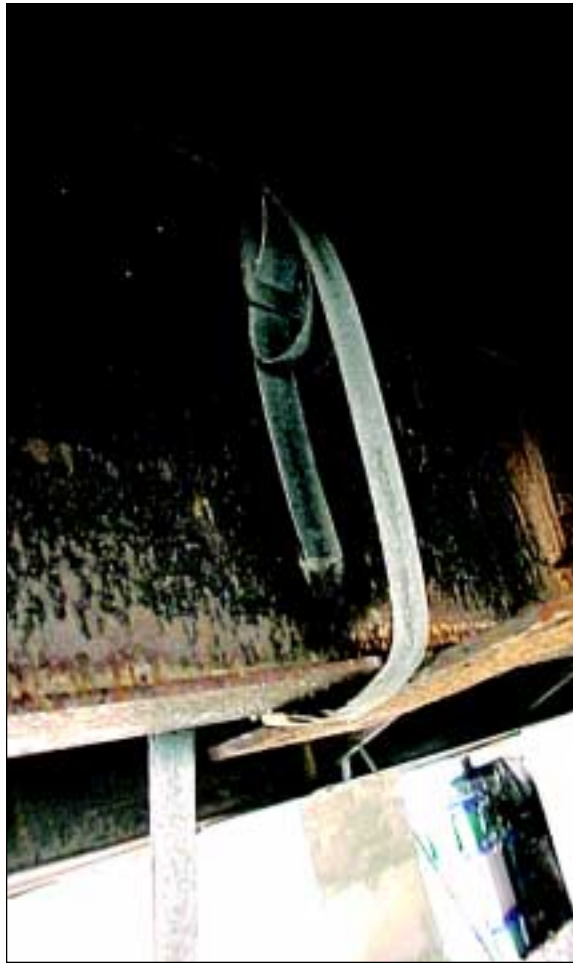
FIGURE 5-25 Proper strap installation.

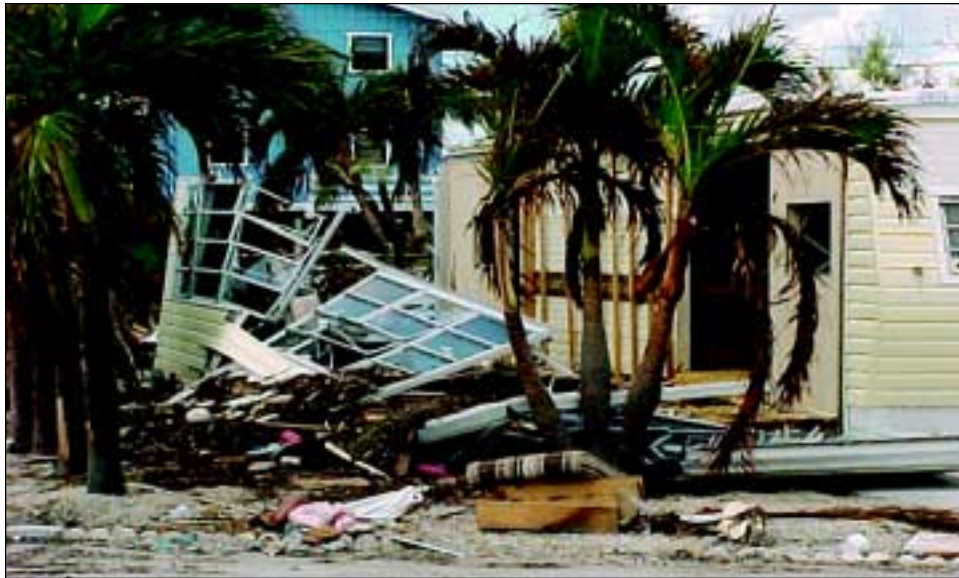
Manufactured homes that sustained the most damage appeared to be older homes with attached decks, porches, and awnings (Figure 5-26). Although undamaged during this storm, the manufactured home in Figure 5-27 could sustain significant damage if hurricane-force winds or storm surges were to get under the deck and pull it away from the building. It should be noted that site-built, attached additions to manufactured homes are no longer permitted after March 1997.

FIGURE 5-26 The addition to this manufactured home was destroyed, causing considerable damage to the rest of the home.
